## CENTRAL INTELLIGENCE AGENCY

## INFORMATION REPORT

COUNTRY	Bulgaria	REPORT	
SUBJECT	Merchant and Military Information Concerning the Port of Burgas	DATE DISTR.	28 October 1953
		NO. OF PAGES	4
DATE OF INFO.		REQUIREMENT	
PLACE ACQUIRED		REFERENCES

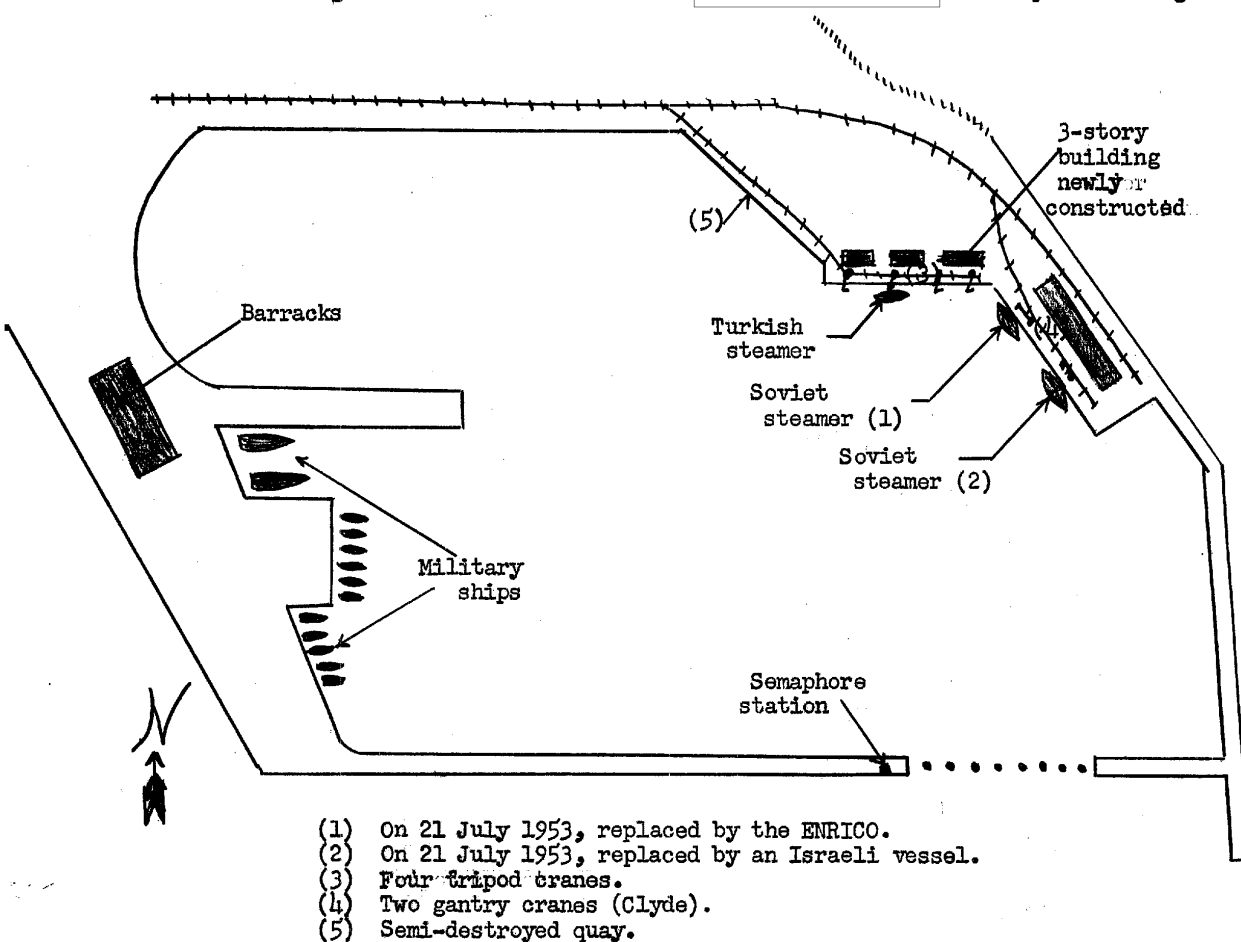
4. As indicated in the sketch on page 2, the west quay has a large 1-story masonry shed of old construction, with spur rail lines on both sides. On the quay there are two gantry cranes of  15 ton capacity, running on tracks and equipped with driver's cabin and unjointed slewing arm extensible to about 10 meters.

5. As indicated in the sketch on page 2, the north quay (still on the east side of the port) has three buildings. The eastern one, a new construction, is three stories high; the middle one, of old construction, is one story high; and the

western one serves as Customs headquarters. The quay is equipped with a spur rail line, and has three beak-type tripod cranes running on tracks, about three tons capacity each. In the vicinity of the west corner of this quay, another crane of the same type and capacity is under construction. [redacted] motor 25X1 parts [redacted] hoisted from a floating pontoon with a fixed gantry crane. 25X1

6. The remaining quay, beyond the corner mentioned above, is still damaged from World War II, and no signs of restoration work were noted.
7. A 3-story barracks in which Naval personnel are quartered is located in the western part of the port. On the quay in front of this building, moored straight in, were the ships which entered the port on the evening of 16 July 1953.
8. The following sketch shows installations [redacted] at the port of Burgas: 25X1

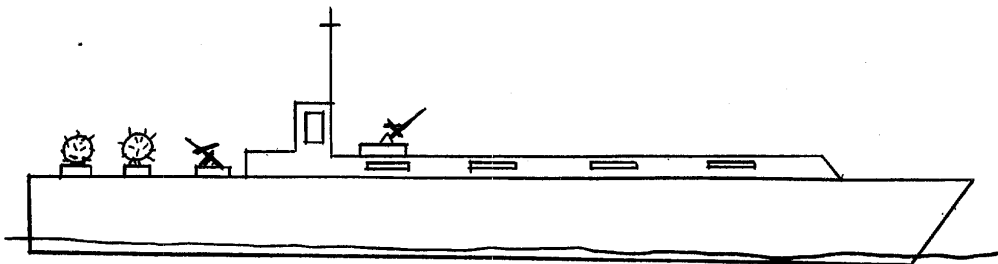
- a. Three German-type landing craft, with unloading doors in the prow, having on board landing troops with complete battle gear; the troops who could be seen wore helmets and were armed;
- b. Two landing craft carrying spherical mines (with spikes) on the stern of the deck; iron guide rails for rolling the mines were arranged on either side; the ships were armed with two 20 mm. guns, one toward the prow and one toward the stern of the bridge; no torpedo tubes were seen; troops were inside the hold;
